Environmental Impact Assessment Report

Teindland Wind Farm

TA A12.2: Watercourse Crossings Inventory

Document prepared by Envams Ltd for: Teindland Wind Farm Ltd

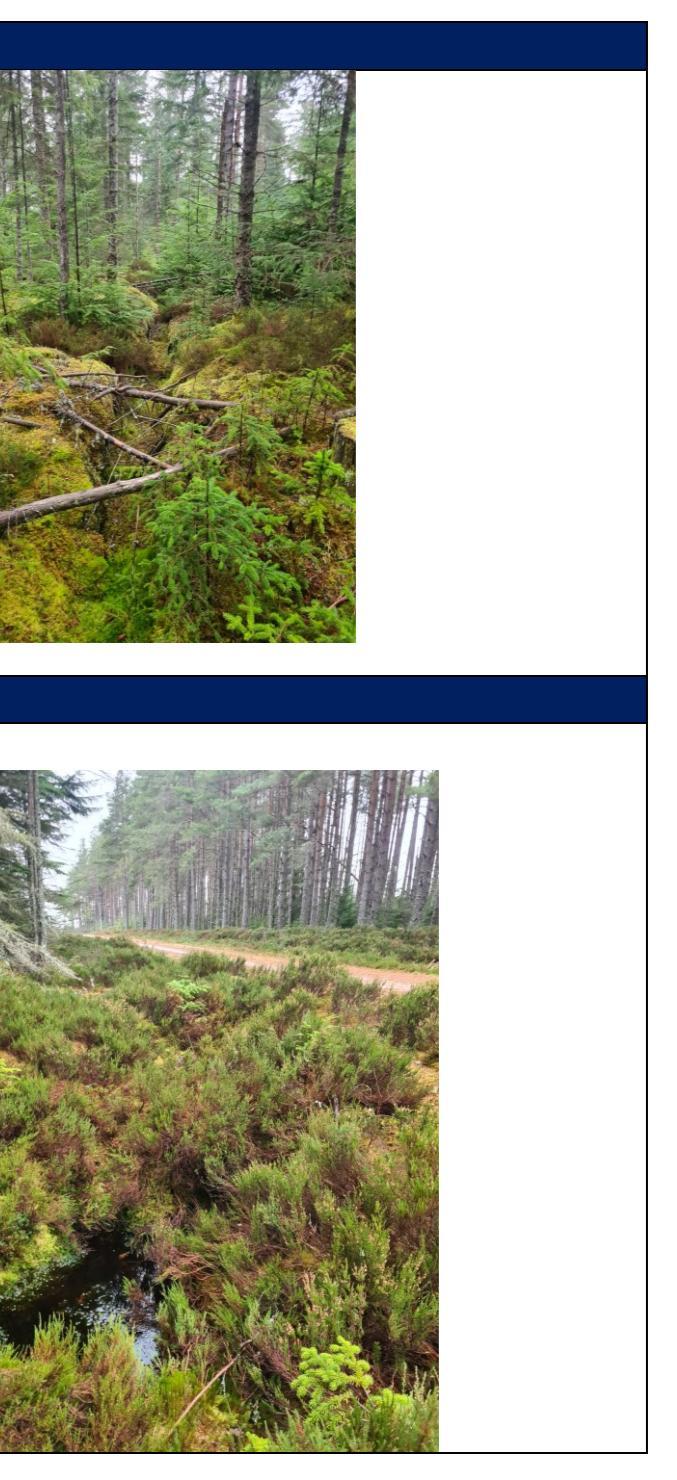
Watercourse crossing	1 (N1)	
Location Description	New crossing, approximately 80 m east of turbine 2.	a control a state a st
Grid-coordinates	328655, 854726	
Description	Tributary of the Red Burn flowing south to north. Approximately 1 m wide and 0.5 m deep.	
	Watercourse was dry.	
Catchment	River Spey	
Crossing Type	Piped culvert	
CAR Requirement	Registration	The second secon
		antilities at the second state of the second s
Watercourse crossing a	2 (E4)	
Location Description	Upgrading crossing, approximately 200 m north of turbine 5.	
Grid-coordinates	328544, 853496	
Description	Unnamed tributary of Burn of Garbity flowing north to south. Small pools located on each	
	side of the existing track. Very slow flow.	
Catchment	River Spey	
Crossing Type	Upgraded piped culvert	
		A A A A
CAR Requirement	Registration	*** ** ** **

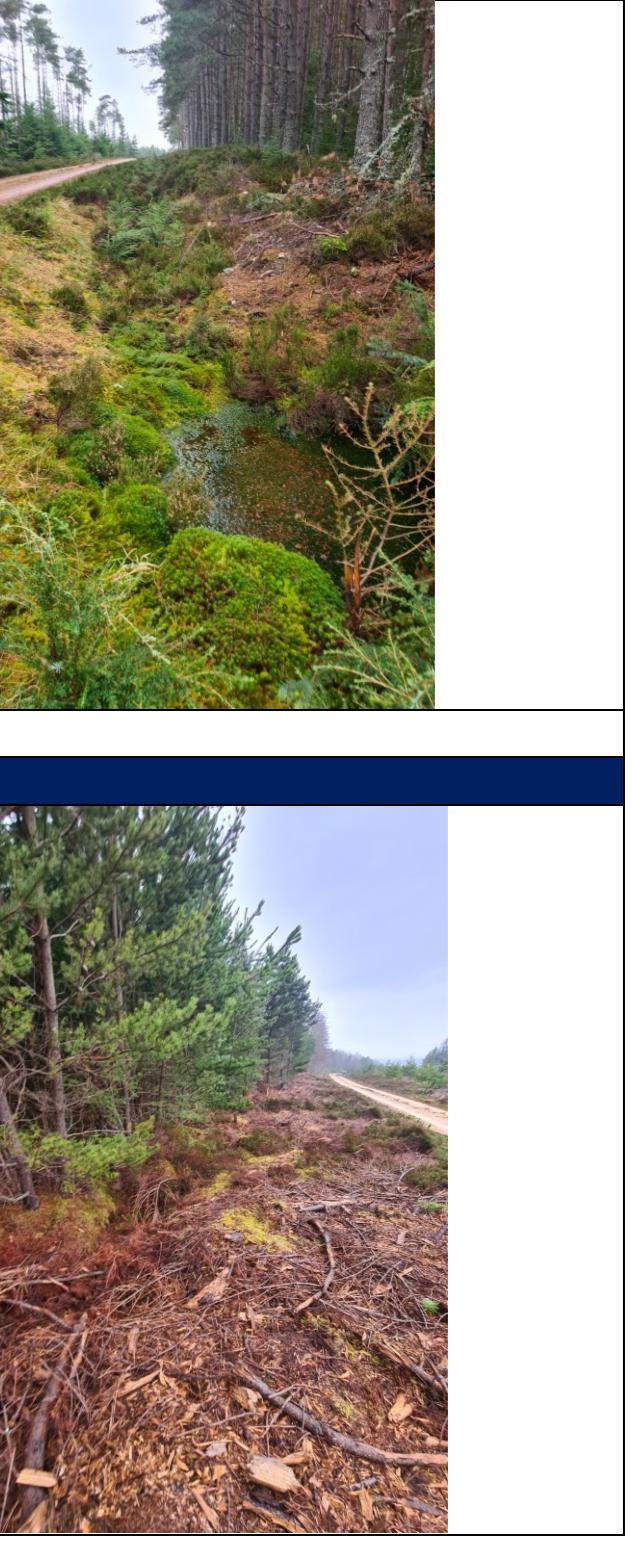
Watercourse crossing 3	(N2)		E CANDERA
Location Description	New crossing, approximately 120 m southeast of turbine 9.	* ** **	A.S.
Grid-Coordinates	328071, 853008		
Description	Diver Cook	** ***	K Z
	River spey	75 1** 3:12.	
crossing type		** **	
CAR Requirement	Registration

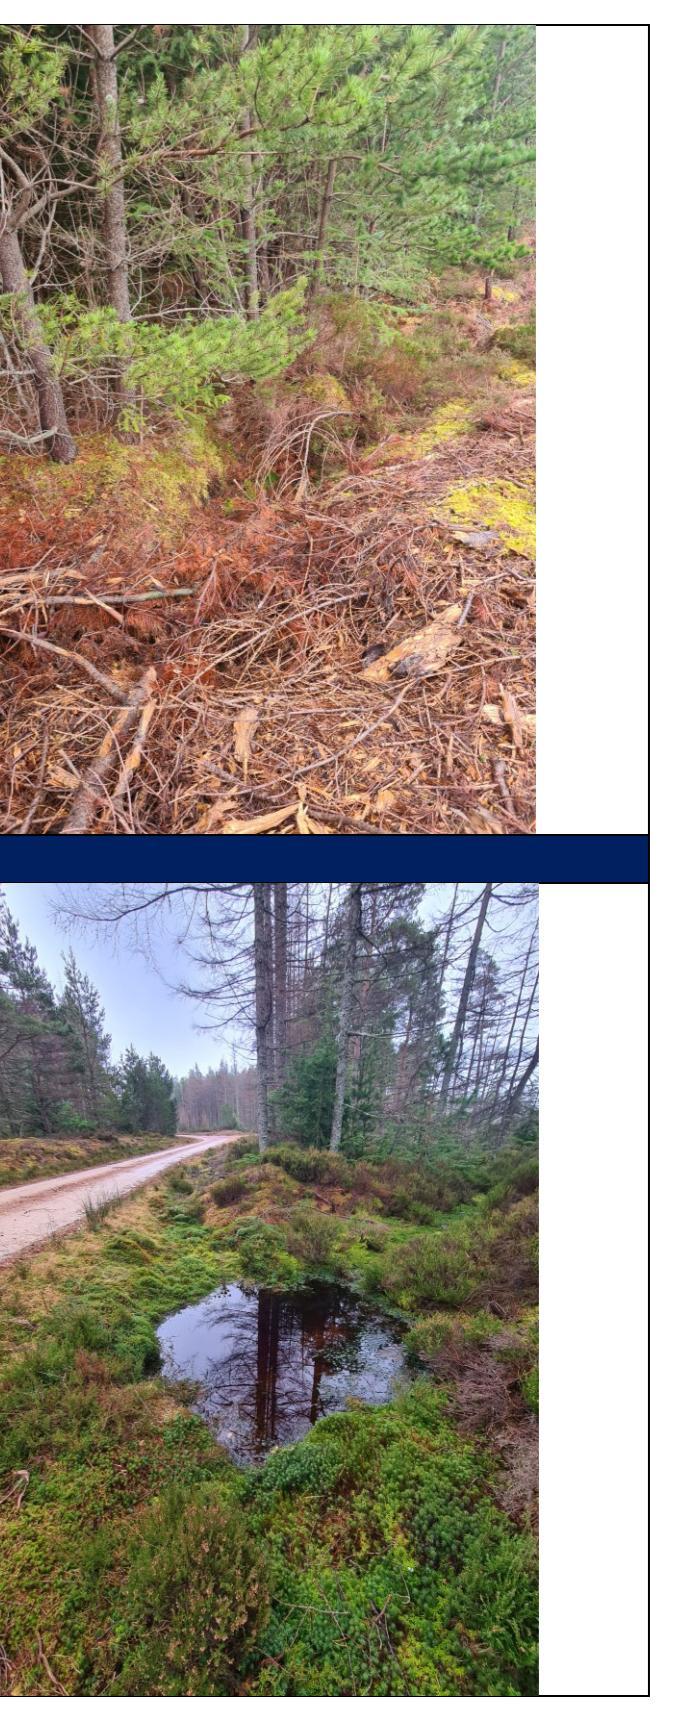
Watercourse crossing 4	(E5)	
Grid-coordinates	328976, 853547	
Description	Unnamed tributary of Burn of Garbity flowing north to south. Small pools located on each side of the existing track. Very slow flow.	
Catchment	River Spey	
Crossing Type CAR Requirement	Upgraded piped culvert Registration

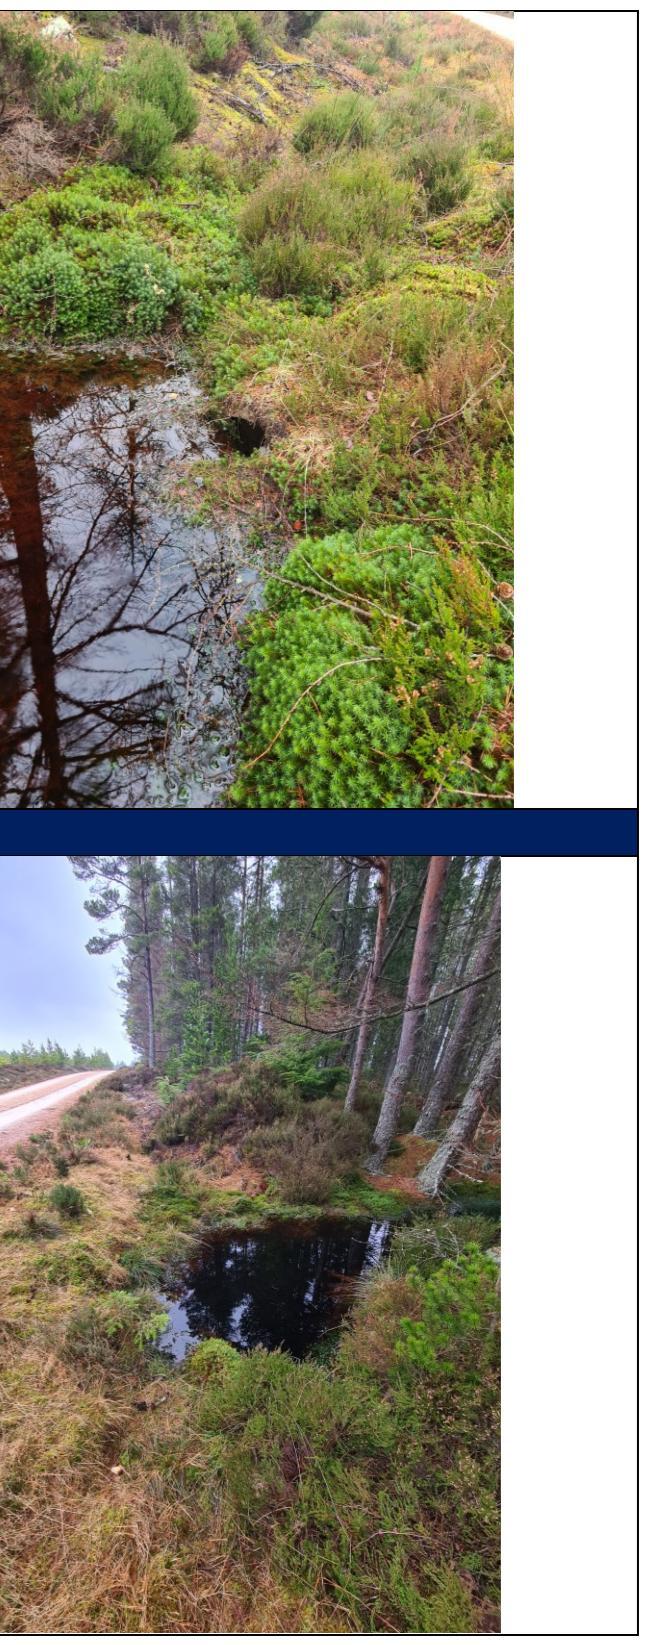
Watercourse crossing 5	(E6)		
Location Description	Upgrading crossing, approximately 85 m west of turbine 3.		
Grid-coordinates	329114, 853706		
Description	Unnamed tributary of Burn of Garbity flowing north to south. Small pools located on each		
	side of the existing track. Very slow flow.		
Catchment	River Spey		
Crossing Type	Upgraded piped culvert	** *** *2 ** **	and the second
CAR Requirement	Registration

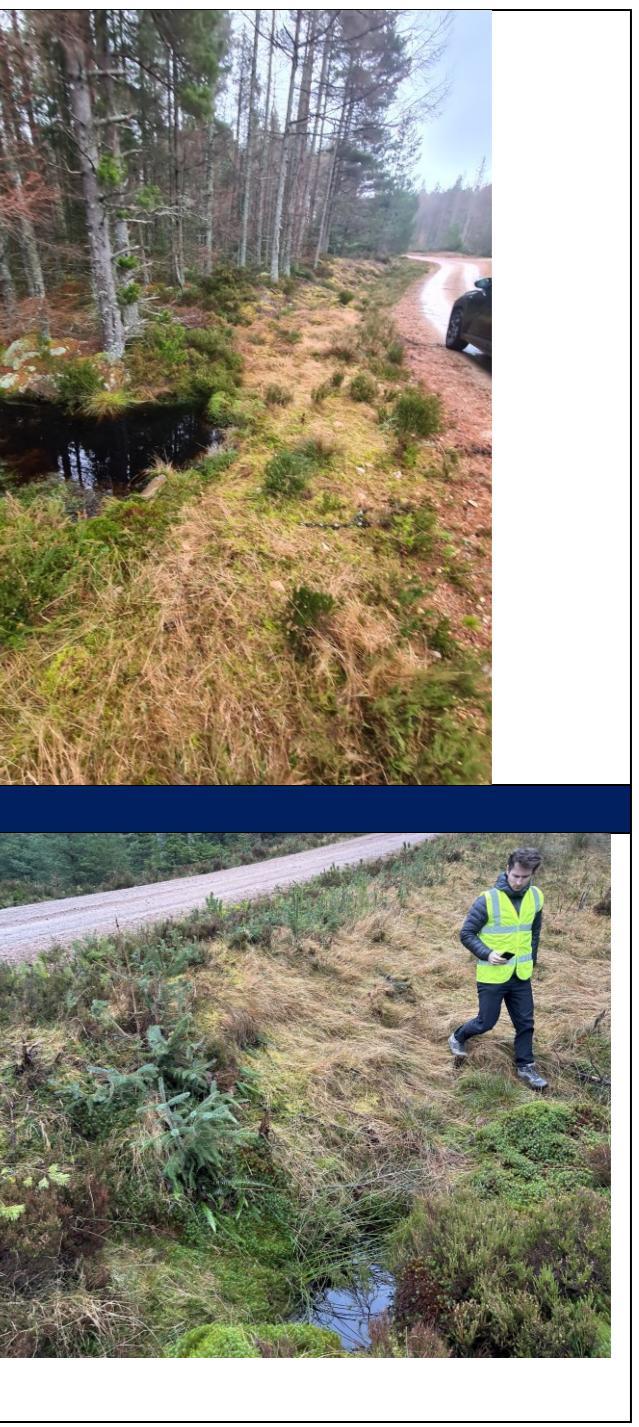
Watercourse crossing 6	(E1)		
Location Description	Opgrading crossing, approximately 435 m southwest of turbine 5.		
Grid-coordinates	328877, 854945		
Description	Cushley Burn flowing south to north. Small pools located on each side of the existing track.		528
Catalana ant	Very slow flow.		
	River Spey	Cushley A**	
Crossing Type	Upgraded piped culvert		
CAR Requirement	Registration

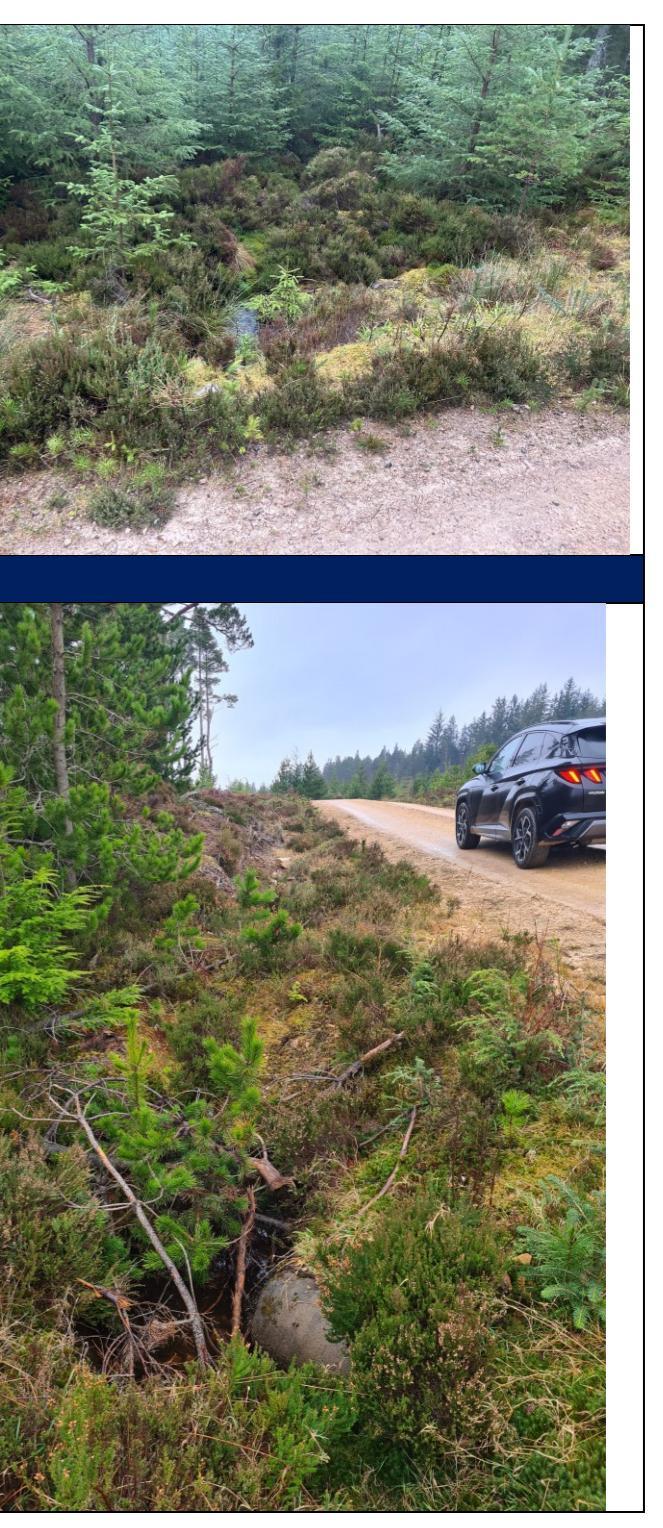
Watercourse crossing 7	(E2)	
Location Description	Upgrading crossing approximately 455 m northwest of turbine 2	**************************************
Grid-coordinates	328965. 854180	- A A A A A Mare
Description	Unnamed tributary of Carra Burn, flowing east. Small pools located on each side of the	
	existing track. Very slow flow.	
Catchment	River Spey	
Crossing Type	Upgraded piped culvert	
CAR Requirement	Registration

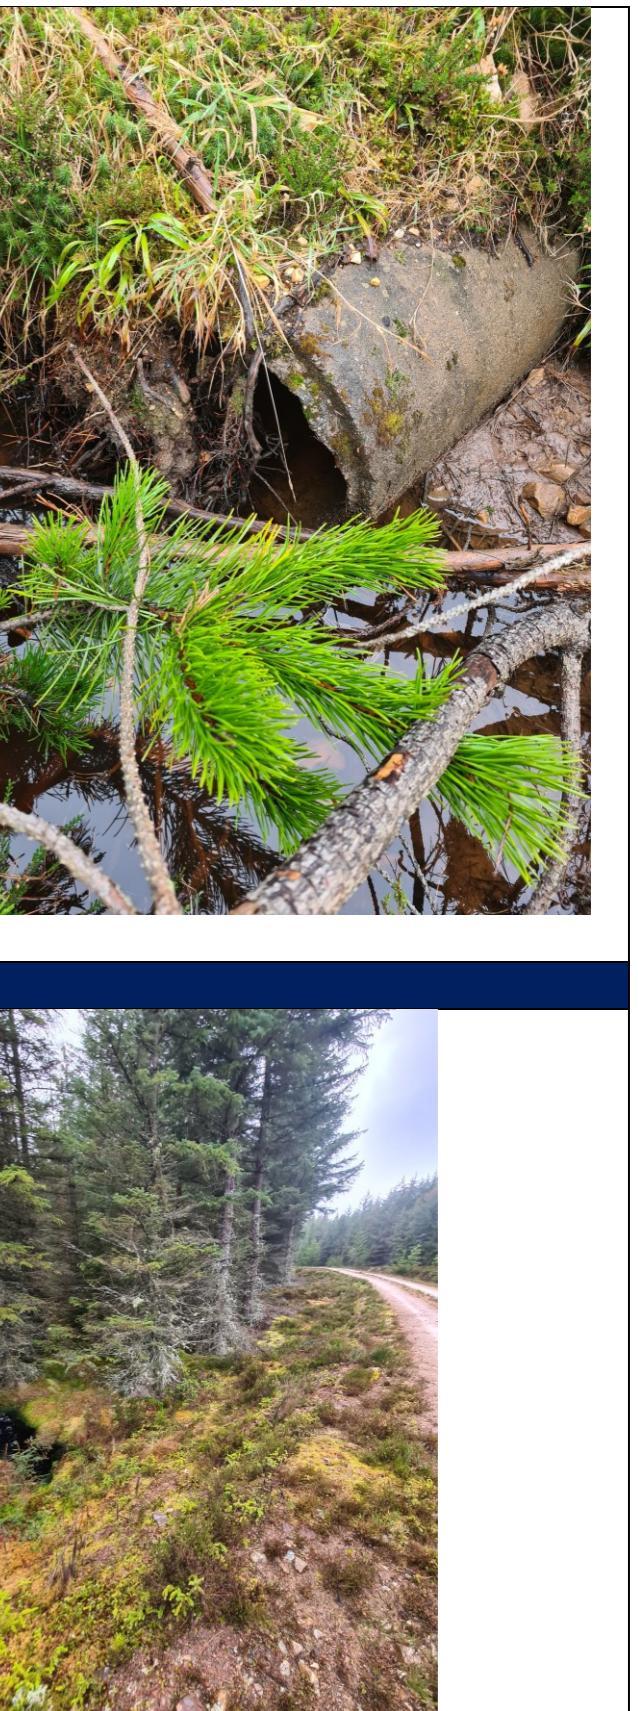
Watercourse crossing 8	(E3)		
Grid-coordinates	327955, 853738	Moss of Findlaysear	C.OT
Description	Whities Stripe, flowing south. Small pools located on each side of the existing track. Very	Seat *	
	slow flow.	Decorrection 24	
Catchment	River Spey	- A state and a state of the st	
Crossing Type	Upgraded piped culvert		
CAR Requirement	Registration
